SERVICE BULLETIN

SB # 180212-974699-9WE

SUBJECT: Incorrect Nut internal threads causing damage during installation.

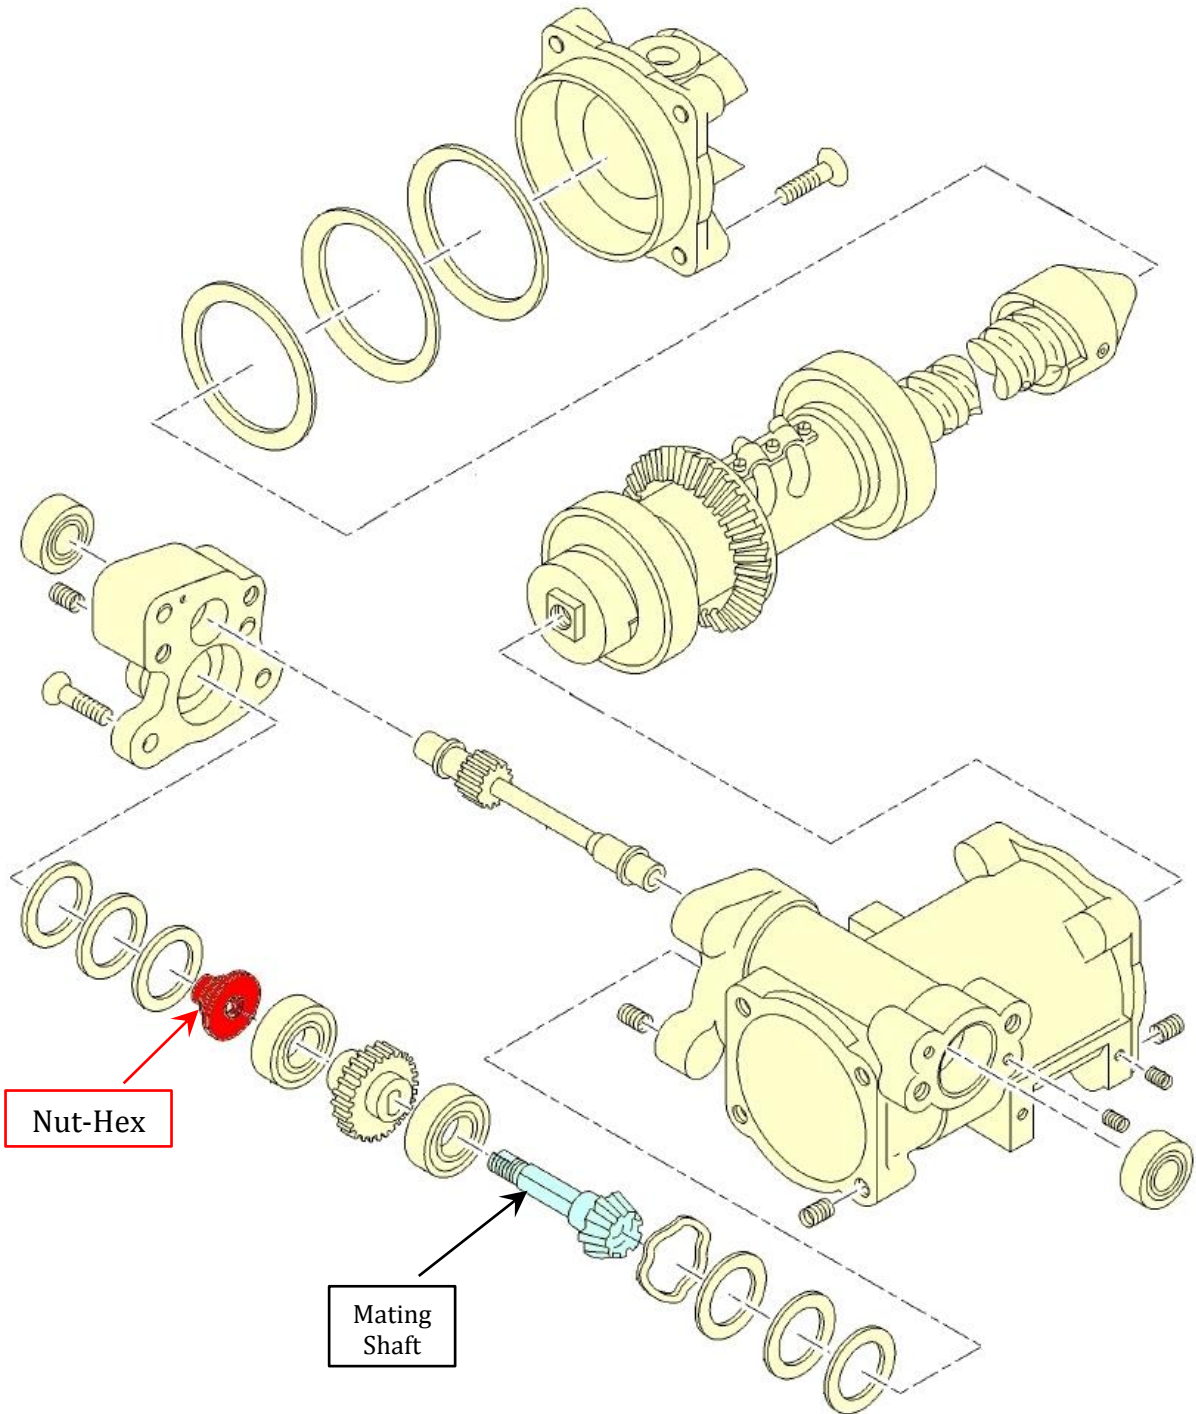
The Nut-Hex is installed into various NHA's and is used as a typical fastener at the end of a shaft in those locations, see one installed example in figure 2 below. The Nut also incorporates an extended cylinder area that is deformed or crimped after being fully installed to ensure the Nut-Hex will not come off the mating shaft, see figure 1 above.

Figure 2: Example of Nut-Hex Installed into NHA
