# SERVICE BULLETIN

**Subject:** Chafing of Aileron Cable Assembly P/N 7227151-522WE.

Part Number	NHA P/N	NHA Description	ATA	Aircraft Application
7227151-522WE	7227150	Controls Instl – Wing Aileron and Trim Tab	27-10-00-05	SAAB 340 Series

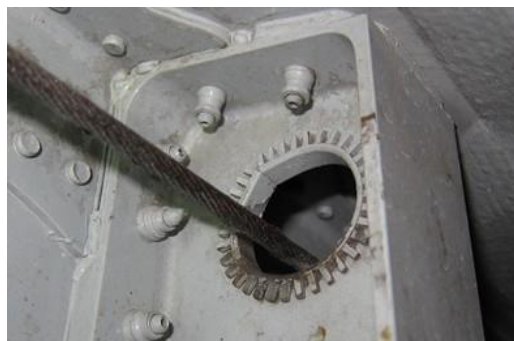
A SAAB 340 operator has reported instances of chafing wear damage on Wencor PMA aileron cables P/N 722151-522WE. The wear was observed during a line maintenance inspection. Upon subsequent inspections, the operator reported finding several more instances of chafing wear damage in their fleet, for a total of five (5) cables exhibiting signs of chafing wear damage. In all instances, the wear affected cables were installed in the forward outboard position at locations where the cables pass through the fairleads as shown below.

Chafing wear damage is dependent upon the installed location of the aileron cables. If the cable passes through a fairlead as in the case of the forward aileron cable run, chafing wear is possible. However, the aft aileron cable run does not pass through any structure, therefore cables installed in this location may not experience chafing damage.

Chafing wear damage has been observed on the outer strands of the 19-strand cables where they pass through the fairleads. Since the forward aileron cables pass through fairleads, those cables may be subject to chafing wear damage. Of the forward aileron cables on each wing, the outboard cables may experience greater vibration and would typically be the one contacting the fairleads and experiencing wear. If chafing wear damage proceeds to the point of cable failure, corresponding aileron control would be lost in the direction controlled by the failed cable. The opposite control direction of that aileron would remain unaffected, as would both control directions of the aileron on the other wing.

Within the compliance time limits of section 3b, inspect the entire length of all Wencor aileron control cable assemblies for chafing wear damage or broken strands. Prior to visual inspection, wipe the cables with a clean cloth. During inspection, operate the ailerons through the full range of motion to reveal all portions of the cable. Also inspect the condition of the fairleads for wear or cracking. Report inspection results to Wencor COS administrator Scott Rollins at [cosboard@wencor.com](mailto:cosboard@wencor.com) or +1-801-491-2447.

Within the compliance time limits of section 3c, remove all Wencor aileron cable assemblies PN 722151-522WE that have chafing wear damage that exceed the limits defined in the SAAB 340 AMM 27-00-00-06. Send the removed cables to Wencor. Do not replace removed aileron cable assemblies with a Wencor PMA aileron cable assembly.

At the operator's discretion, any serviceable Wencor PMA aileron cable assemblies that are found within the wear limits of the SAAB 340 AMM 27-00-00-06 may be repositioned from the forward aileron cable run to the rear aileron cable run that does not pass through any fairleads. Service experience has shown that cables in this location may exhibit reduced chafing wear.

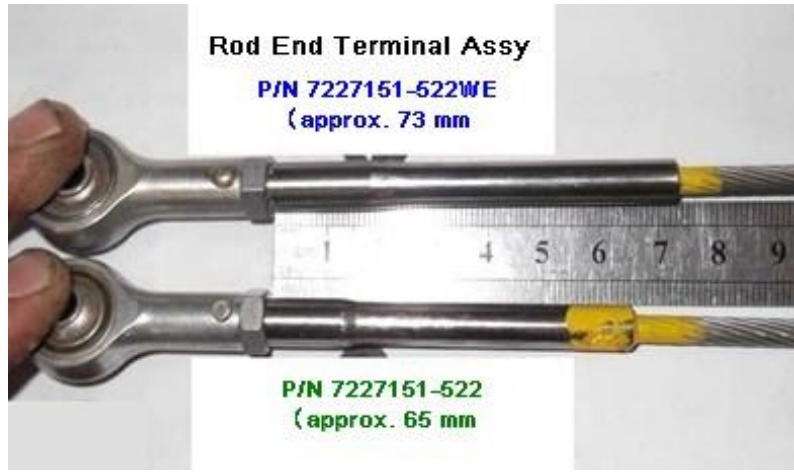
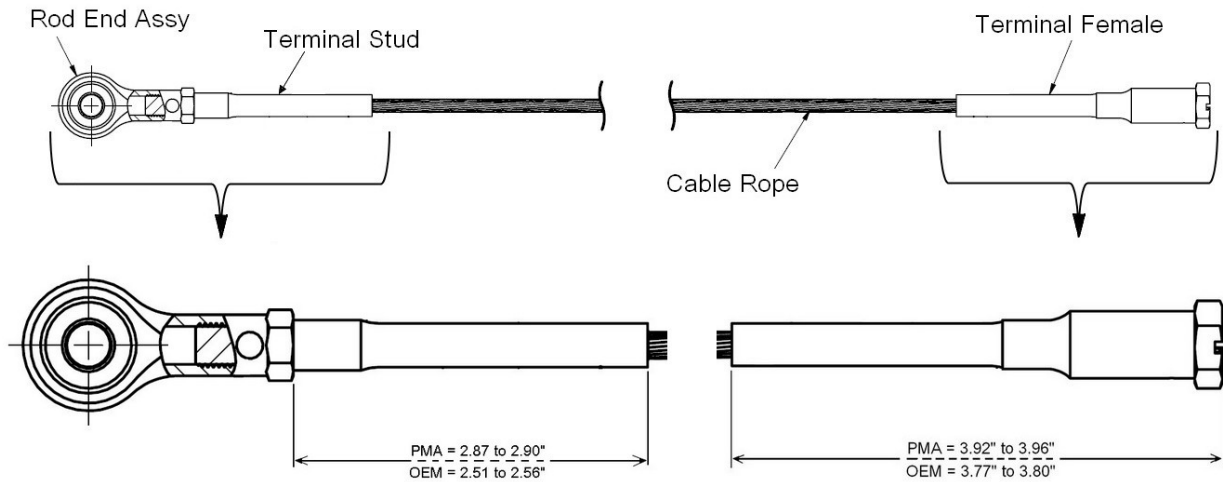
Following the operator's reports of chafing wear damage Wencor developed a method for distinguishing the OEM cables -521 and -522 from the Wencor PMA cables -522WE by measuring the length of the cable terminals as shown below.

Aileron Cable Identification Summary			
	-521	-522	-522WE
<b>Rod End Terminal Length</b>	Shorter *2.51"- 2.56"	Shorter *2.51"- 2.56"	Longer *2.87"- 2.90"
<b>Female Terminal Length</b>	Shorter *3.77"- 3.80"	Shorter *3.77"- 3.80"	Longer *3.92"- 3.96"
