# SERVICE BULLETIN

**Subject:** Liberated Head of Tubular Rivet PN 800162WE, installed in JT8D Engine 7<sup>th</sup> Stage High Pressure Compressor (HPC), (reference SIL 130418-001, dated 4/18/2013).

Service Bulletin No: 130617-001  
 Page 1 of 4

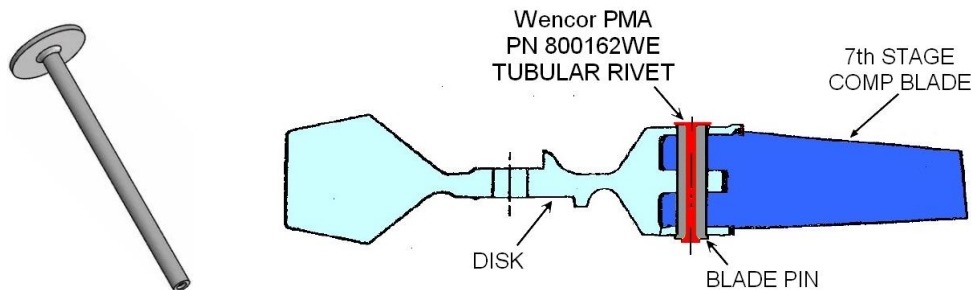
**Figure 1, Rivet ISO View & Section View of Installed Rivet**

Between January and July 2013, two customers have discovered a total of 13 Wencor Tubular Rivets that had liberated the rivet head after an unknown time in service. The rivets were installed in the 7<sup>th</sup> stage HPC section of JT8D series engines, and were assembled between January 2011 thru December 2011. On 9 engines a single rivet head out of 60 total rivets was found missing and on 2 engines two rivet heads were found missing. No engine related failures or detectable loss of performance in engine operation has been caused by the failed (liberated head) rivets at any customer.

The headless rivets were discovered during maintenance for non-related reasons when the engine was rotated to the vertical position and due to gravity, the blade pin fell out of the 7<sup>th</sup> stage disk or was discovered during boroscope inspection of the 7<sup>th</sup> stage HPC section before engine removal.

Loss of the rivet head could allow the affected 7<sup>th</sup> stage blade pin to move forward out of the 7<sup>th</sup> stage disk. Due to the blade-to-disk retention design, the blade pin would need to move forward at least half the length of the blade pin before the 7<sup>th</sup> stage blade could be liberated due to fracture of the disk rail. A liberated 7<sup>th</sup> stage blade would result in an engine shut down.

Within the compliance time described in section 3a, perform a preemptive borescope inspection of JT8D engines that have undergone a 7<sup>th</sup> stage HPC blade replacement using Wencor Tubular Rivets PN 800162WE any time between August 1, 2010 and December 31, 2011. Inspect the 7<sup>th</sup> stage Tubular Rivet heads from the aft side of the 7<sup>th</sup> stage HPC disk.

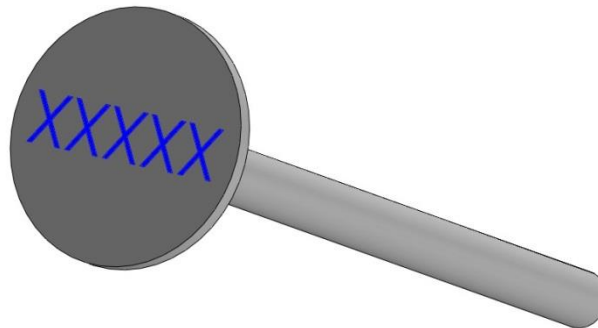
**Figure 2:** Wencor Rivets with Marking on Rivet Head

The repetitive borescope inspection may cease when all Wencor rivets that do not have any marking on the rivet head as shown below in Figure 2 have been removed from service. Rivets with marking on the rivet head have been inspected for cracks under the rivet head and screened for proper manufacturing.

Within the compliance time described in section 3b, implement an operator defined, on-going borescope inspection plan such as at every B check, where the 7<sup>th</sup> stage HPC section is inspected for Wencor Turbular Rivets PN 800162WE that may have missing rivet heads.
