SERVICE BULLETIN

Subject: Guide Assembly with Small Bore and Improper Bonded O-Ring

Service Bulletin No: 130814-001
Page 1 of 5

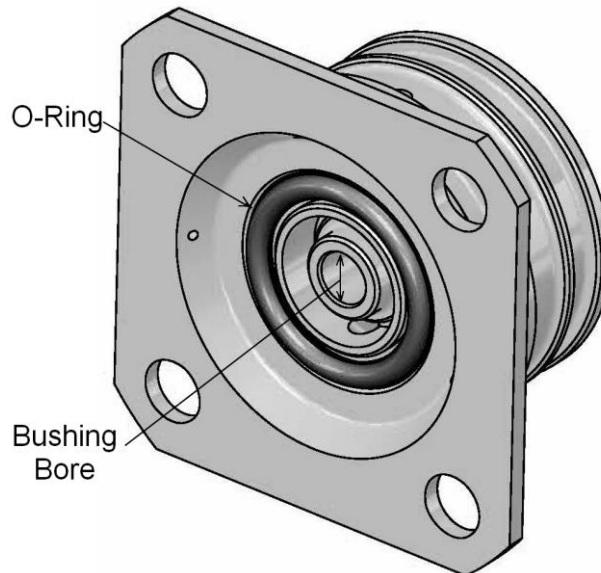
As a result of a single customer report, Wencor has confirmed that the Guide Assembly PN 3162808-6WE has a bushing bore that may be slightly undersize and the bonded in O-ring may have an inadequate bond that would allow the O-ring to come out of the groove at assembly or in service.

Figure 1, Guide Assy Showing the O-ring and Bushing Bore

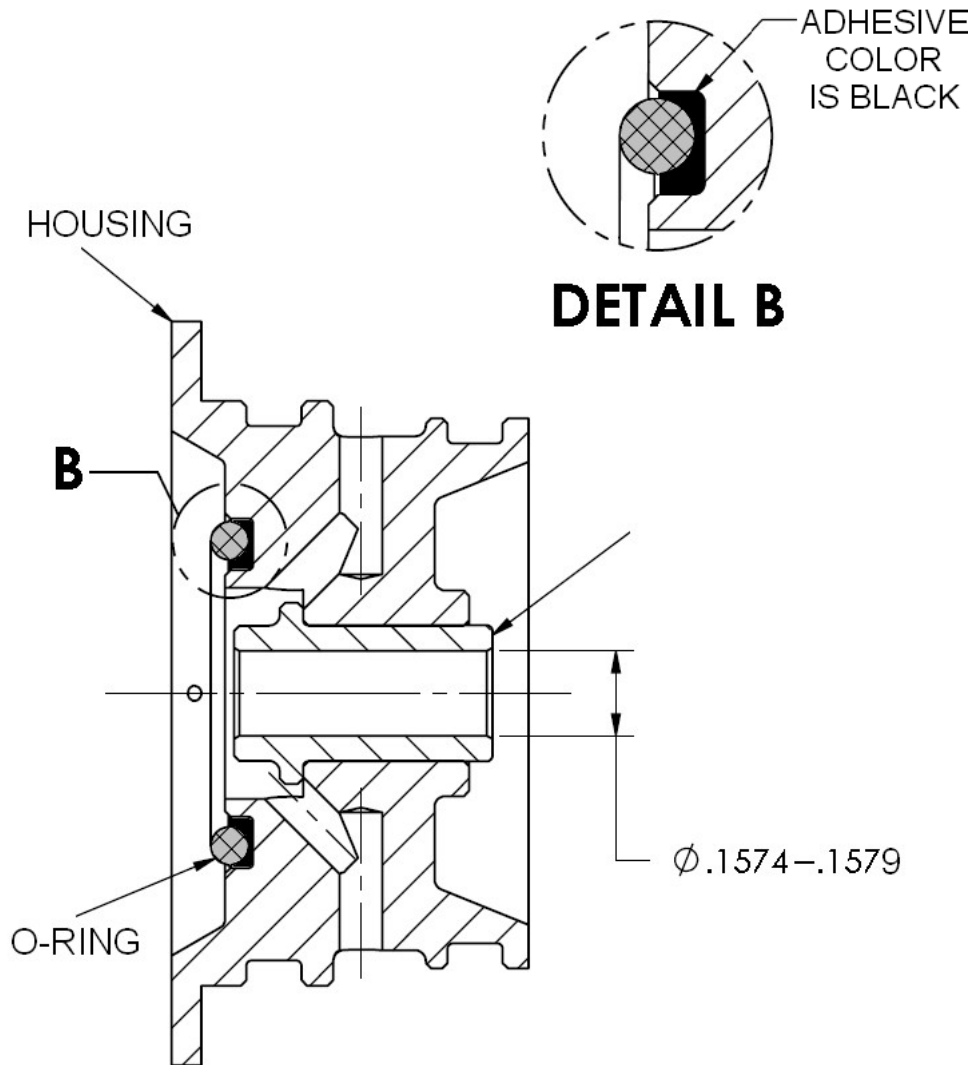
The bushing bore was manufactured with an ID size of .1570" - .1575" and the required ID size is .1574" - .1579". This allows for the possibility of an undersized condition which will prevent the guide shaft from installing into the bushing bore of the Guide Assembly.

The bonding process to bond the O-ring in the groove of the Guide Assembly may not have been done properly to achieve an acceptable bonded joint. This could possibly allow the O-ring to fall out or be dislodged from the groove.

Figure 2, Cross-Section View of Guide Assy

- I. Verify the bushing bore ID is sized at 0.1574" – 0.1579" as shown in Figure 2. If the bushing bore ID size is within these limits the Guide Assembly is acceptable. If the bushing bore ID size is outside these limits, the Guide Assembly should be returned to Wencor as described in section 4 of this SB.

- II. Verify the bonded O-ring is properly bonded to the Guide Assembly. Using light finger pressure, verify all bonded surfaces of the O-ring are intact (no gaps) and the O-ring will remain in the groove. The adhesive should be visibly present on the ID and OD of the O-ring as shown in Figure 2 with enough adhesive to achieve this requirement. If the O-ring is found to be fully bonded to the Guide Assembly, the bond is acceptable. If the O-ring bond does not meet this criteria, the Guide Assembly should be returned to Wencor as described in section 4 of this SB.

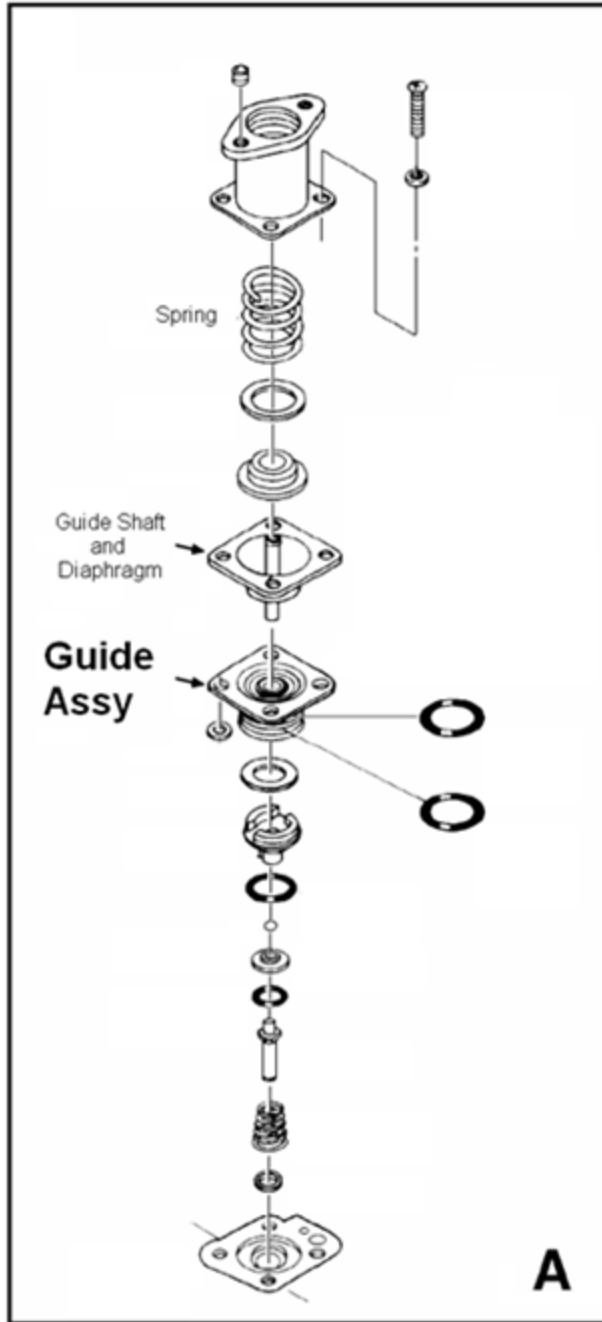
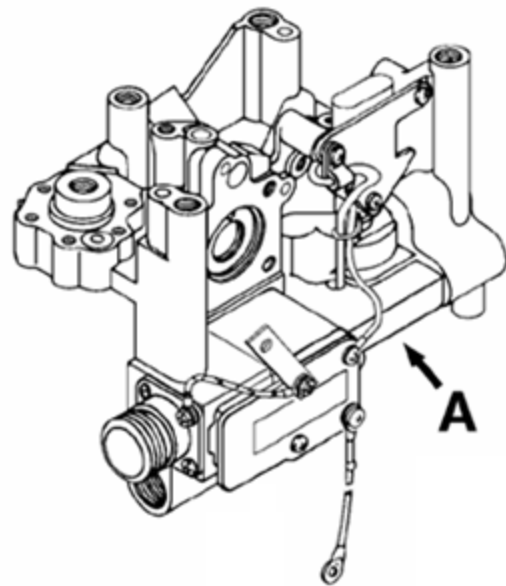
The Guide Assembly is installed in the over-pressure sensor sub-assembly of the NHA High Stage Pilot as shown in Figure 3. The Guide Assembly serves two main purposes: (a) provide a bore to "guide" the guide shaft as it moves in and out through the Guide Assembly bushing and (b) provide a seal to prevent bleed air leakage when the plate on the guide shaft contacts the bonded in-place O-ring.

Figure 3, Guide Assembly Installed Into High Stage Pilot
