# SERVICE BULLETIN

**SB # 160330-5905587WE**

**SUBJECT:** Excess epoxy on the inside surfaces of the Fuel Filter Element that may become detached and flow into the downstream fuel system.

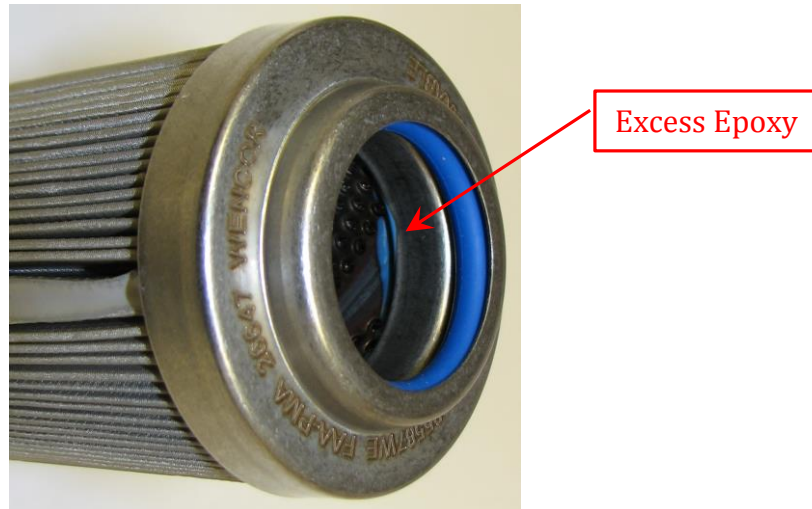
During the manufacturing of the Fuel Filter Element, epoxy is used to attach the filter components to the filter end caps. Some Filters were manufactured with excess epoxy on the inner surfaces of the Filter as shown in Figure 1. The excess epoxy may become detached and potentially contaminate the downstream fuel system components and may ultimately lead to engine malfunction.

**Figure 1, Excess Epoxy on Inner Surface of Fuel Filter**

The effects from the excess epoxy would be unnoticeable unless all or a portion of the blue epoxy material became dislodged and flowed into the downstream fuel system. Although Wencor has never had a customer report of fuel system failure from dislodged epoxy, it is possible that this scenario may occur. Dislodged bits of epoxy could affect the operation of the downstream Fuel Control Unit (FCU) and ultimately affect normal operation of the affected engine.

Within the compliance time given below in section 6, any Wencor Fuel Filter Element, PN 5905587WE, that was purchased from Wencor before March 2016, that is currently installed into the NHA Power Driven Rotary Fuel Pump shall be removed and be visually inspected for excess epoxy on the inner surfaces. Any blue colored epoxy located on any of the Filter inner surfaces as shown in Figure 2 is cause for removal and replacement of the Fuel Filter Element per section 7 below.

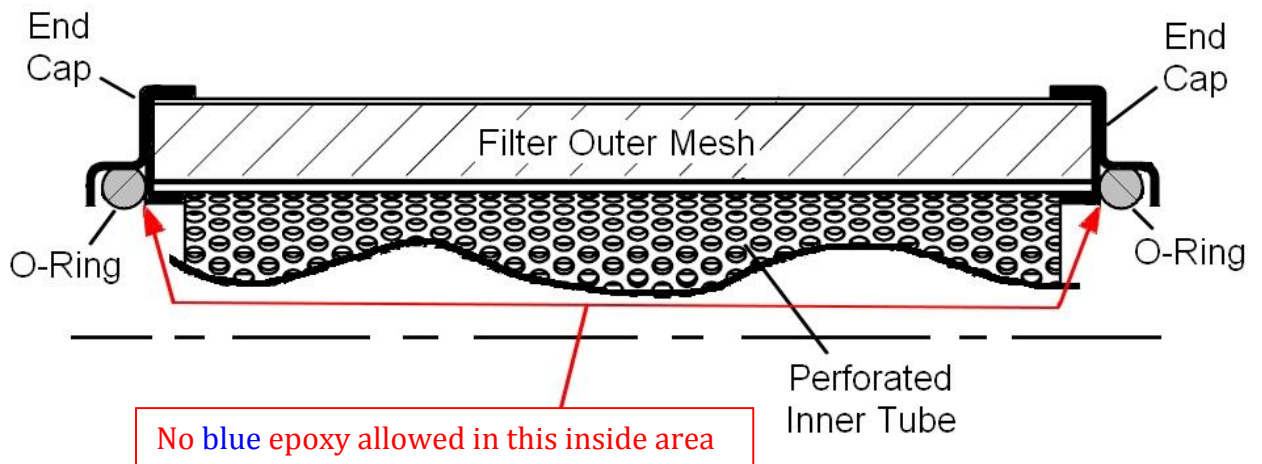
**Figure 2**, Filter Section View Showing Area for Visual Inspection for Blue Epoxy

Fuel Filter Elements that are found to be free of excess epoxy shall be permanently marked on the end cap with “**OK**” using a manual scribe or hand held vibro-engraver (reference SAE AS478-2D or -5A) and may be reinstalled for continued service if all other instructions for continued airworthiness have been verified.

All Wencor Fuel Filter Element's that were purchased from Wencor before March 2016 and are not installed into the NHA Power Driven Rotary Fuel Pump or are installed into spare Pumps that are not yet in service shall be visually inspected for excess epoxy located on the inner surfaces as shown in Figure 2. If excess epoxy is found, the Filter shall be returned to Wencor for replacement per section 7 below.

Fuel Filter Elements that are found to be free of excess epoxy shall be permanently marked on the end cap with "OK" using a manual scribe or hand held vibro-engraver (reference SAE AS478-2D or -5A) and may be put into service.

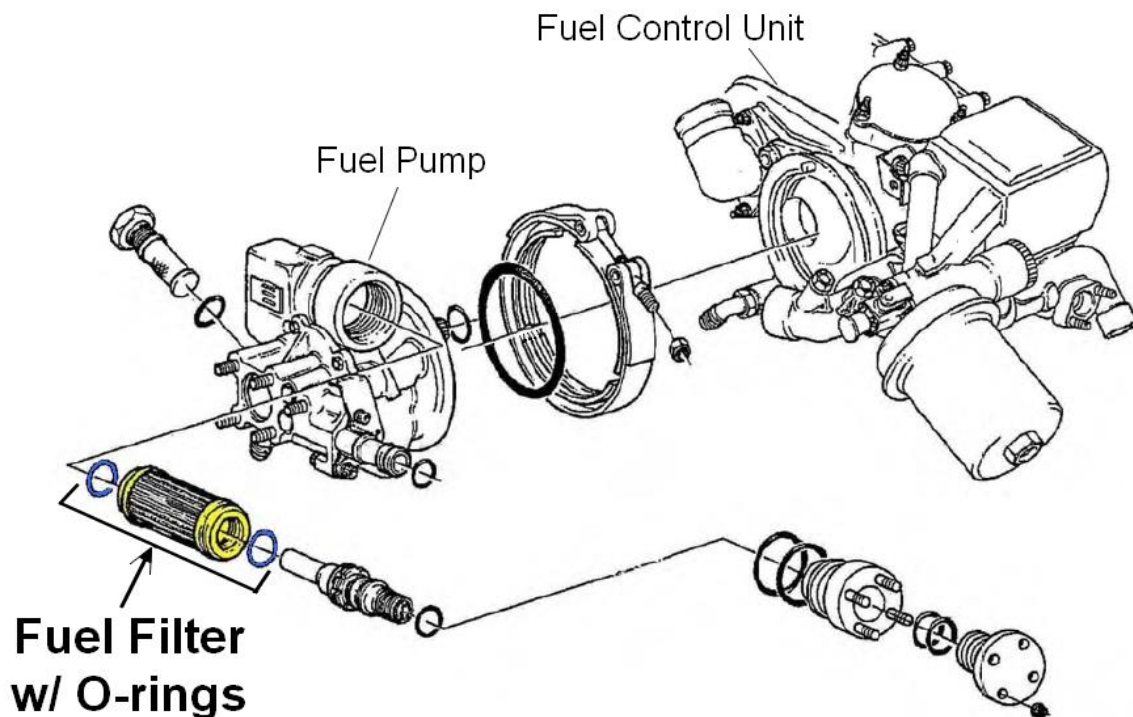
The Fuel Filter Element is installed into the outlet port of the Power Driven Rotary Fuel Pump as shown in Figure 3. The purpose of the Fuel Filter Element is to filter out any contaminants in the fuel before the fuel flows downstream into the other fuel system components.

**Figure 3:** Fuel Filter Element Installed into Fuel Pump
