SERVICE BULLETIN

SB # 180212-974699-9WE

SUBJECT: Incorrect Nut internal threads causing damage during installation.

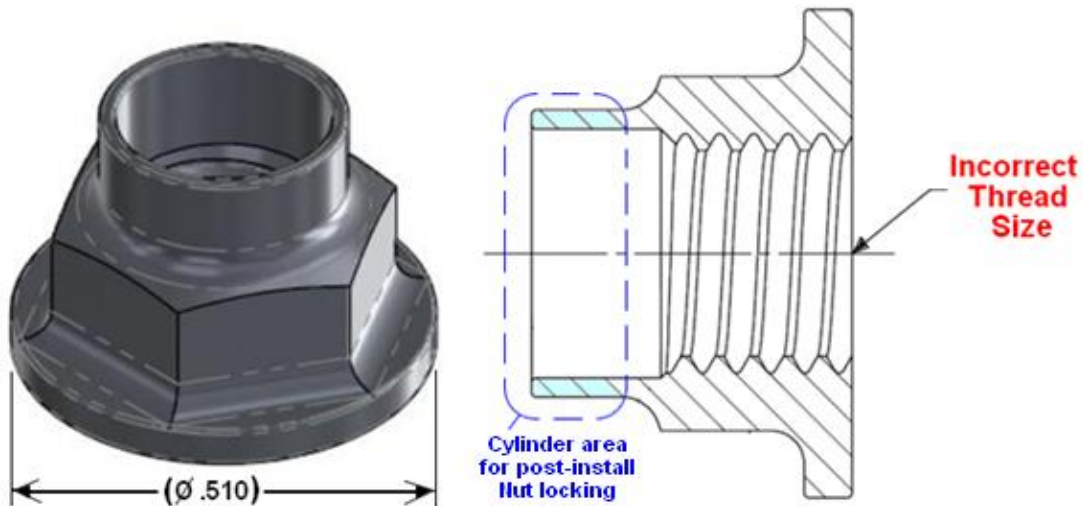
The Nut internal threads were incorrectly designed and manufactured with a threads per inch (TPI) of **.250-32 UNJEF-3B**. The correct threads per inch is **.250-28 UNJF-3B**.

Figure 1, Image of Nut-Hex Showing Incorrect Internal Thread

The incorrect Nut-Hex threads per inch (TPI) would prevent proper installation of the Nut onto the mating shaft of the NHA and the Nut would not be able to be fully installed onto the mating shaft without exceeding the required assembly torque value defined in the NHA CMM. However, if excessive force was used to attempt to fully install the Nut, it would cause thread damage to both the Nut and the mating shaft.

Following the applicable NHA CMM instructions, remove the Wencor Nut-Hex and return the removed Nut-Hex to Wencor. Inspect the mating shaft threads for damage, replace the mating shaft if damaged threads are found. Replace the Nut-Hex with an approved Nut-Hex with the proper threads per inch (.250-28) and properly follow the NHA CMM instructions for assembly.

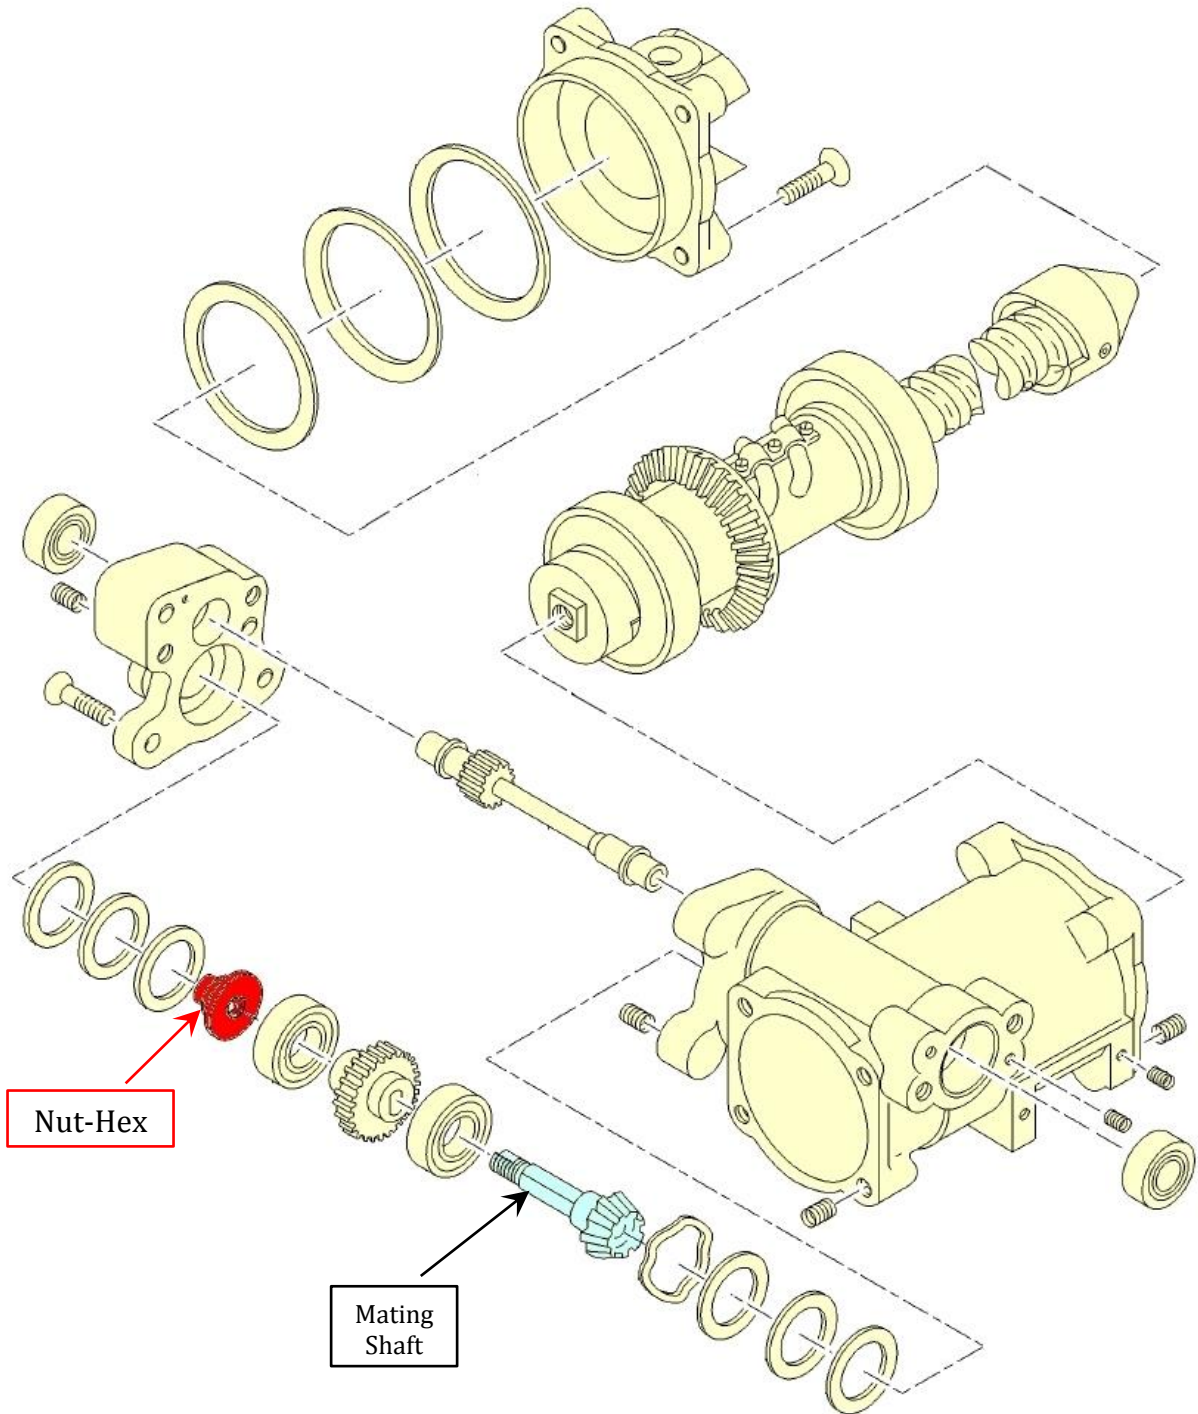
The Nut-Hex is installed into various NHA's and is used as a typical fastener at the end of a shaft in those locations, see one installed example in figure 2 below. The Nut also incorporates an extended cylinder area that is deformed or crimped after being fully installed to ensure the Nut-Hex will not come off the mating shaft, see figure 1 above.

Figure 2: Example of Nut-Hex Installed into NHA
