# SERVICE INFORMATION LETTER

**Subject:** Shaft External Spline Slightly Oversize Possibly Affecting Installation

Service Information Letter No: 130123-001  
 Page 1 of 4

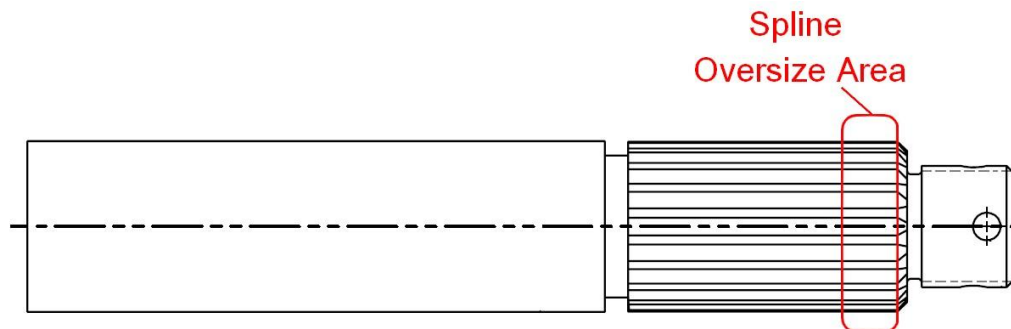
An unknown quantity of the Wencor Inner Shaft's PN 65B13152-3WE were manufactured with a slightly oversize external spline (approx. .0004") as measured on the pitch diameter over pins. The oversize condition was found to be near the end of the spline area as shown in Figure 1. This condition may affect or prevent the installation of the Shaft into the NHA if the internal spline on the mating part is at its minimum size creating a tight fit condition.

However, it is also possible that this condition will not ever be noticed during an installation because of the size condition of the mating part.

**Figure 1, Inner Shaft Showing Oversize Spline Area**

The manufacturing process of the Shaft did not account for the possibility of spline taper, which appears to be the cause for the out of tolerance condition. When the Shaft spline was inspected, the end of the spline area was not measured, but only the middle area was measured which was found to be within tolerance. The end of the spline area, which was slightly out of tolerance was not properly inspected, which allowed the out of tolerance Shafts to be accepted, sold to customers and put into service.

To confirm acceptable usage of the Wencor Inner Shaft, the user shall perform a fit check with the NHA. If the Wencor Inner Shaft can be installed in a normal manner according to the CMM (see Figure 2), the Wencor Inner Shaft can be put into service without any concerns.

If the user suspects an out of tolerance condition on the spline or has trouble installing the Wencor Inner Shaft into the NHA, the Shaft should be returned to Wencor for replacement.

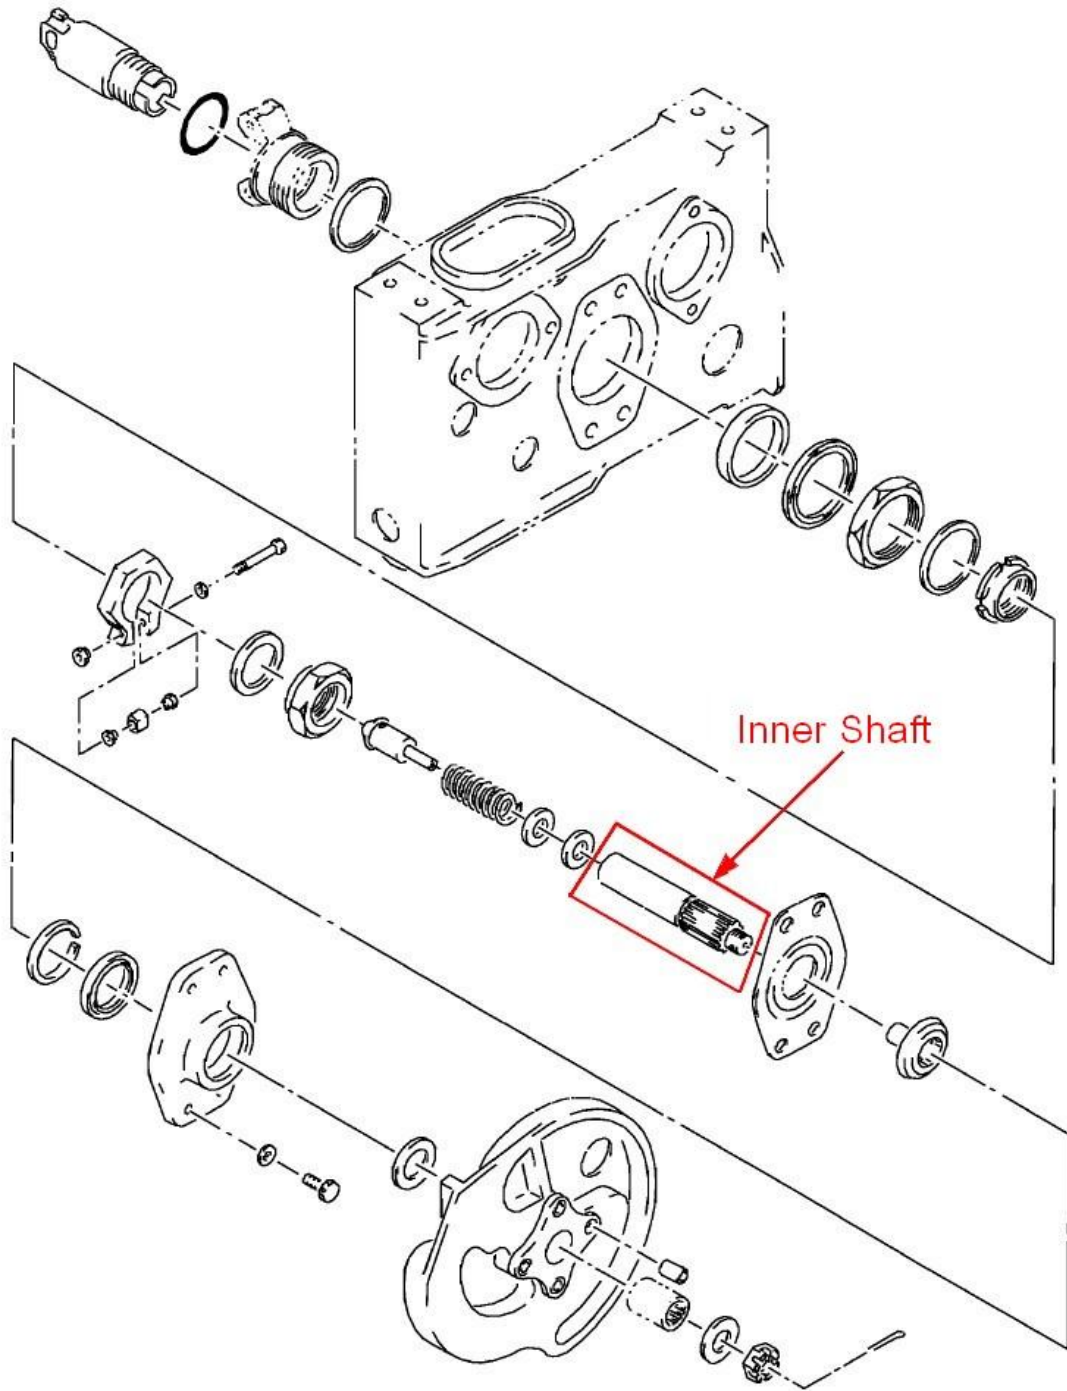
**Figure 2, Inner Shaft in Passenger Door Handle Mechanism**
