SERVICE INFORMATION LETTER

Subject: Shaft External Spline Slightly Oversize Possibly Affecting Installation

Service Information Letter No: 130123-001
 Page 1 of 4

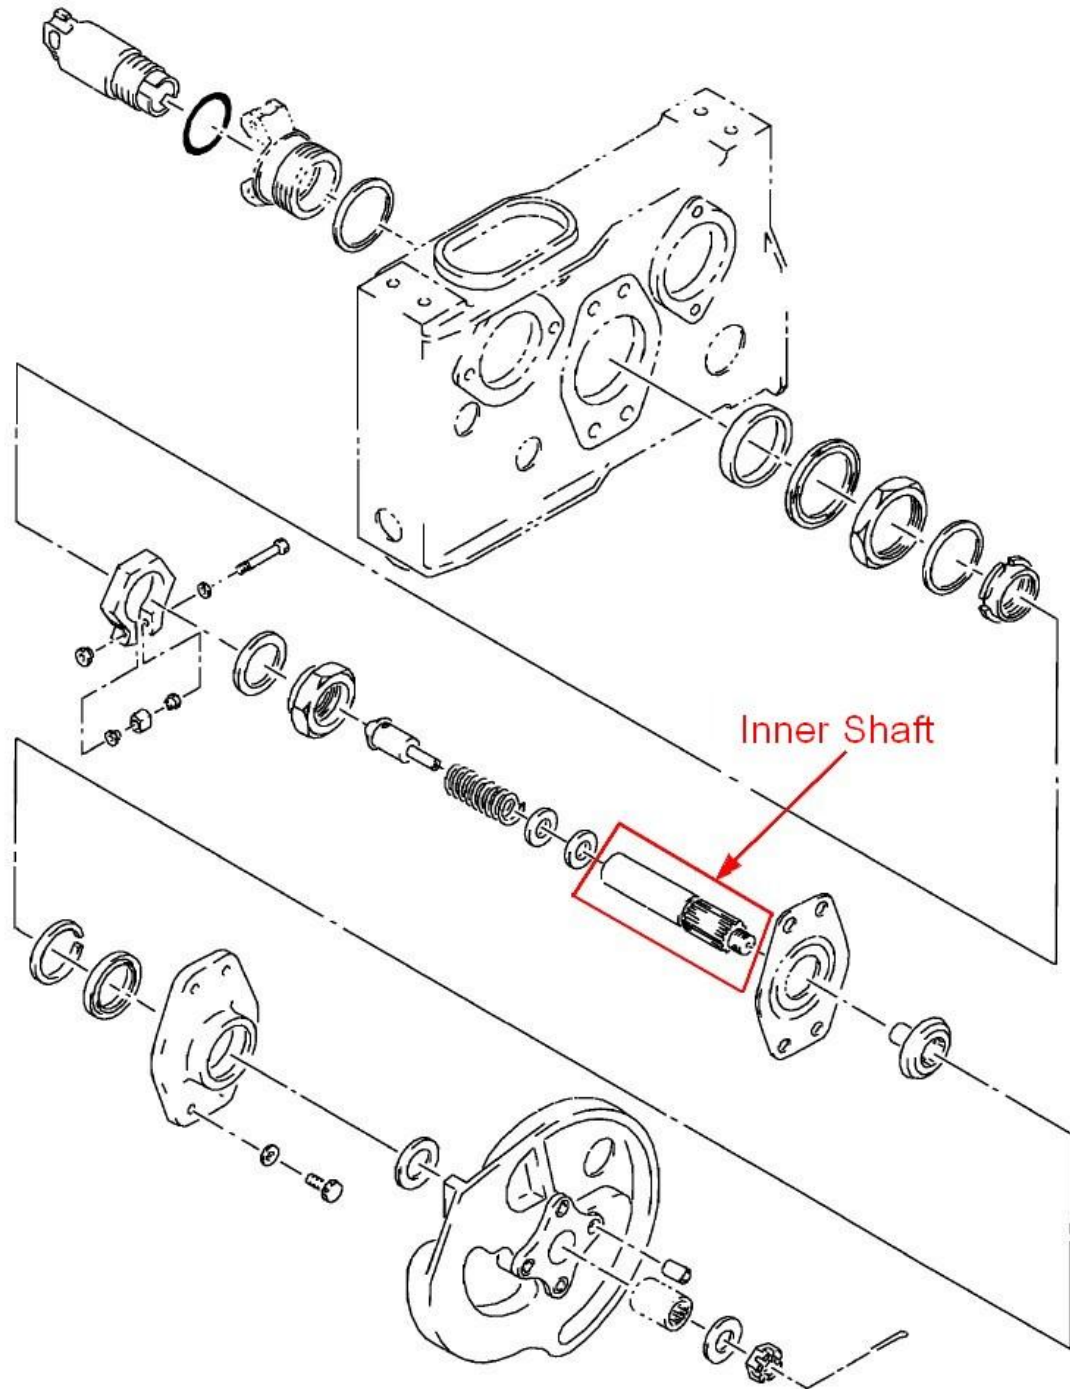
Figure 2, Inner Shaft in Passenger Door Handle Mechanism

To confirm acceptable usage of the Wencor Inner Shaft, the user shall perform a fit check with the NHA. If the Wencor Inner Shaft can be installed in a normal manner according to the CMM (see Figure 2), the Wencor Inner Shaft can be put into service without any concerns.
