# SERVICE INFORMATION LETTER

**Subject:** Rivet P/N 800162WE, JT8D-219 7<sup>TH</sup>-Stage High-Pressure Compressor (HPC)

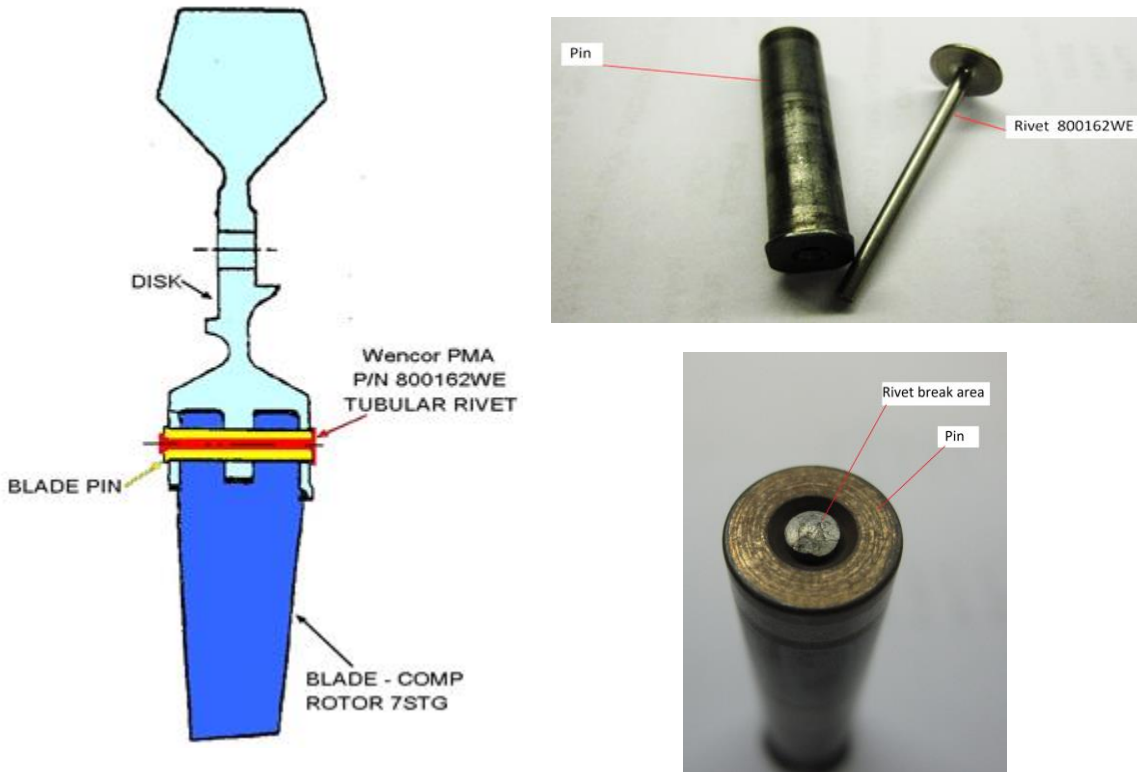
Customer found isolated rivets with missing heads after service.

During January and February, 2013, a customer identified two JT8D-219 engines, overhauled within a short time span in 2011, with one each failed rivets. The rivets had experienced head separations in service. Although the failures did not have an operational effect on the engines, concerns about potential axial movement of the blade attachment pins prompted borescope inspections in the field of more than 60 engines with HPC overhauls performed by the same customer during 2011. The inspections viewed the forward and aft sides of the 7<sup>th</sup>-stage HPC disk in order to identify pin movement and rivet head separations. Three additional engines with one failed rivet head each, and two engines with two failed rivet heads each were identified. In all cases, there had been no axial movement of the corresponding blade attachment pins.

FIGURE 1. Left: 7<sup>th</sup>-Stage HPC blade-disk assembly showing rivet P/N 800162WE (red) within the blade retaining pin (yellow). There are 60 rivet/pin assemblies per disk. Top right: blade retaining pin and Rivet P/N 800162WE. Bottom right: one of the rivets with missing head as found during engine disassembly.

A comprehensive investigation indicated that the failed rivets had been compromised by an isolated manufacturing abnormality, likely limited to a few parts from a single manufacturing lot, and that their weakened condition may have been aggravated by certain installation practices at the customer. The compromised rivets failed some time after installation. The incident engines continued to operate normally after the failure of the rivets, although in at least two cases the rivet heads caused minor downstream foreign-object damage (FOD) to the HPC section. In no case had there been any movement of the blade attachment pins following rivet head failure.

- I. Advise engine overhaul personnel to look for 7<sup>th</sup>-stage HPC rivets with missing heads.
- II. If any such rivets are discovered, save the failed parts, and report the event to Wencor COS administrator Scott Rollins at [srollins@wencor.com](mailto:srollins@wencor.com), or +1-801-491-2447.
