# SERVICE INFORMATION LETTER

**Subject:** Loss of Electrical Continuity on Wencor Plug Assembly

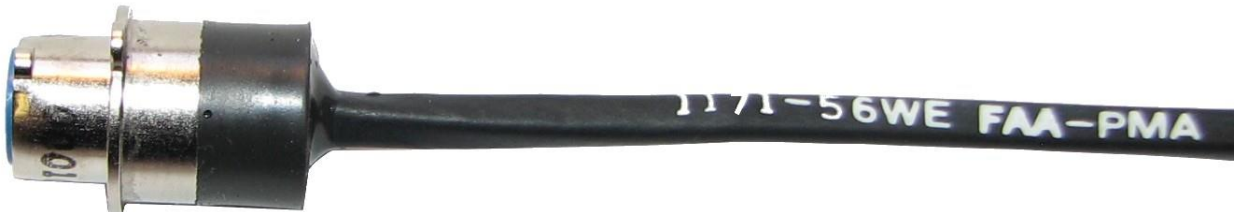
**Figure 1:** Wencor Plug Assembly PN 1171-56WE

Loss of electrical continuity at the Plug Assembly connector due to wire breakage from over-crimping during manufacturing.

Upon examination of the discrepant parts, a broken wire was found at the crimp connection between the wire and pin. The cause of the broken wire appears to be random over-crimping during manufacturing of the PMA Plug Assembly. Over-crimping caused a weakening of the wire at the crimp location, reducing the wire's tensile strength.

Every Plug Assembly produced by Wencor is tested for continuity during the manufacturing process and all the Plug Assemblies passed this test; however, as the leads were bent during installation to fit the Plug Assembly into the NHA actuator housing, tension on the crimp connection caused the wire to break.

Any end user of the Wencor Plug Assembly that has already installed the PMA part and passed the NHA test requirements as defined in the OEM CMM may remain in service without any change in aircraft safety. However, any operator that discovers a failed Wencor Plug Assembly should return it to Wencor for replacement per the Wencor warranty agreement.

End users who have Wencor Plug Assemblies in their stock which have not yet been installed may, at their discretion, return the PMA part for a replacement of a Plug Assembly which has been manufactured using a more controlled crimping process to prevent over-crimping.

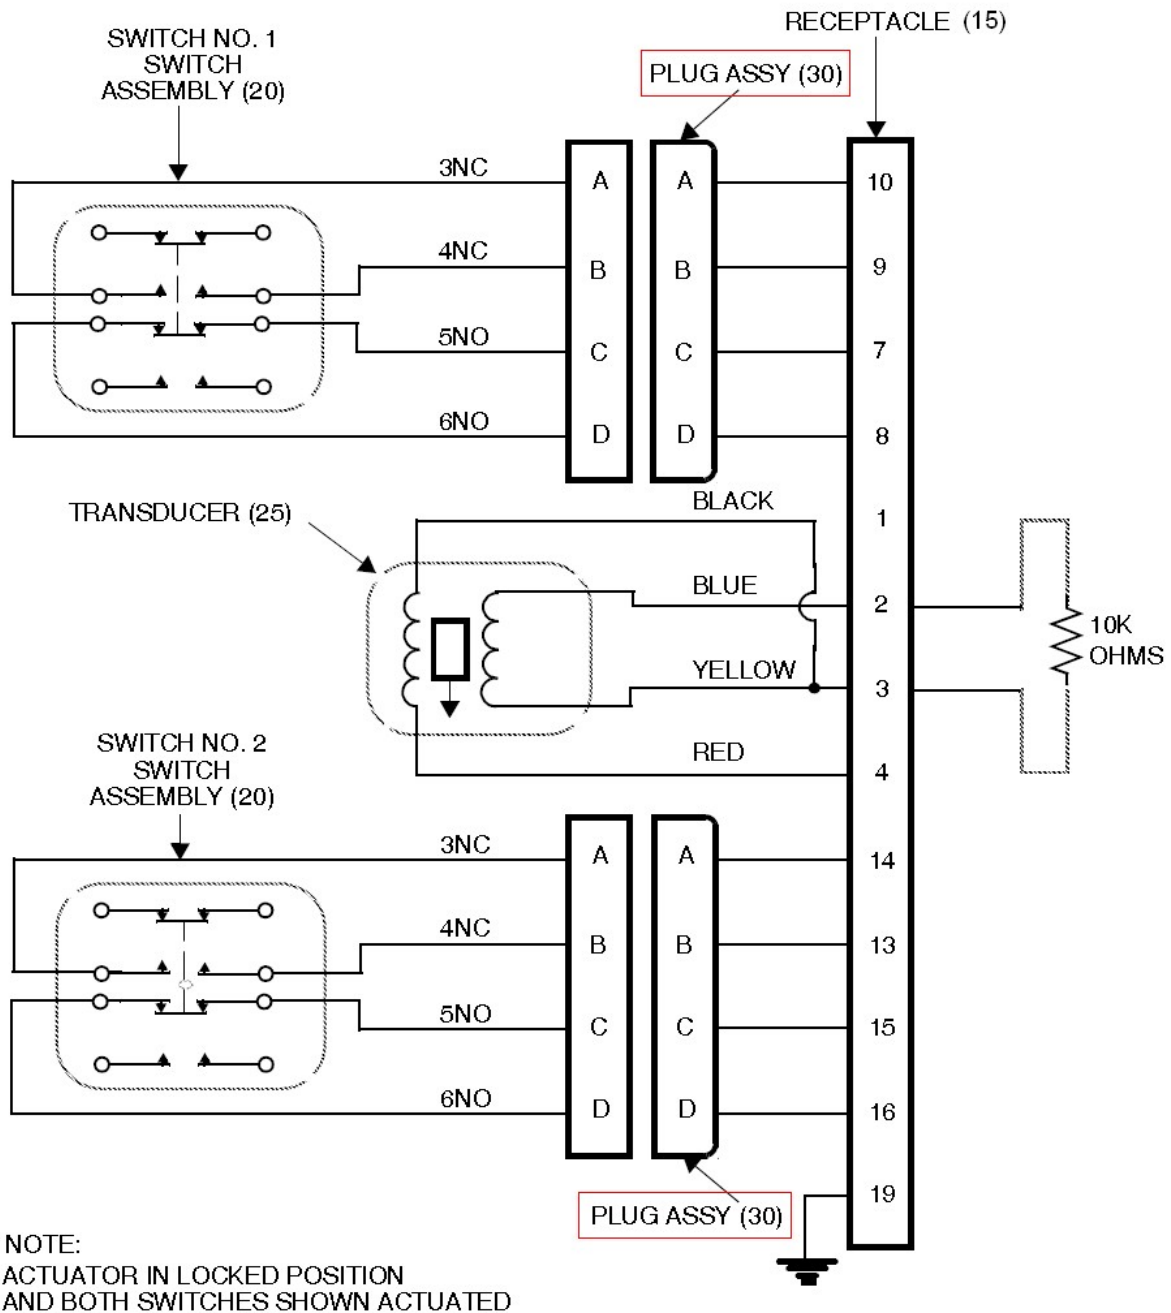
**Figure 2: NHA Actuator Electrical Schematic**

The Plug Assembly is installed within the NHA actuator body housing connecting the Switch Assemblies to the Receptacle as shown below in Figure 2.
