SERVICE INFORMATION LETTER

Subject: Installation Recommendations for Wencor Tubular Rivet PN 800162WE, installed in the JT8D Engine 7th Stage High Pressure Compressor (HPC) Disk.

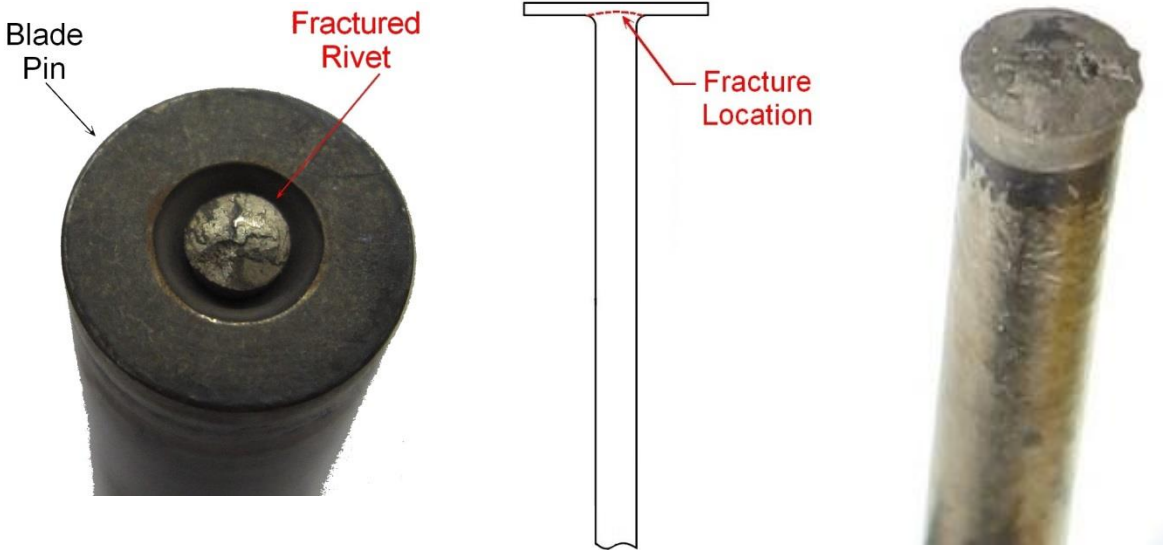
Figure 2, 3 Images of Rivet Fracture

The investigation showed the failure mode of the rivet to be fracture and liberation of the rivet head. In all cases, the fracture was located at the radius between the rivet head and shank as shown in Figure 2.

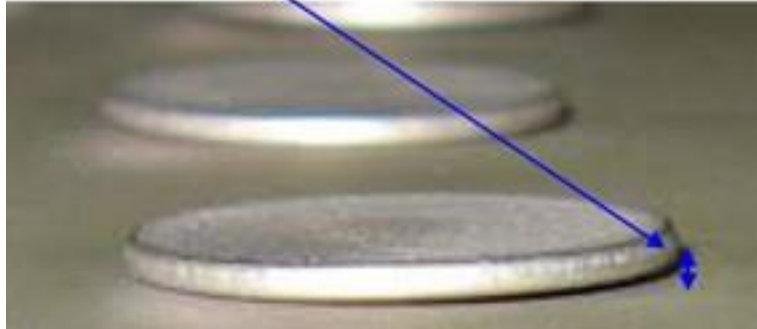
Figure 3, Showing Undesirable Gap Under Rivet Head

As shown below in Figure 3, examination of some rivets still installed in the disk showed that the rivet heads were not setting flat or parallel against the blade pin or disk surface after installation. This results in a gap between the underside of the rivet head and top side of the blade pin. Wencor considers any gap that is larger than .003" a contributing factor that could cause stress in the rivet radius that could contribute to head liberation.

Any gap over .003" is undesirable

The gap shown in Figure 3, results in uneven contact between the underside of the rivet head and the blade pin. The uneven contact is shown by witness marks on the underside of the rivet head as shown below in Figure 4. The uneven contact creates an undesirable bending stress at the rivet radius which could contribute to head liberation.

After the rivet flaring process, during step 2 of task 72-36-02-44-003-002 (JT8D-1/17 EMM for PN 481672) or in task 72-36-02-44-003-003 (JT8D-209/219 for PN 773128), verify that the gap between the rivet head and the blade pin as shown in Figure 8 does not exceed .003”.

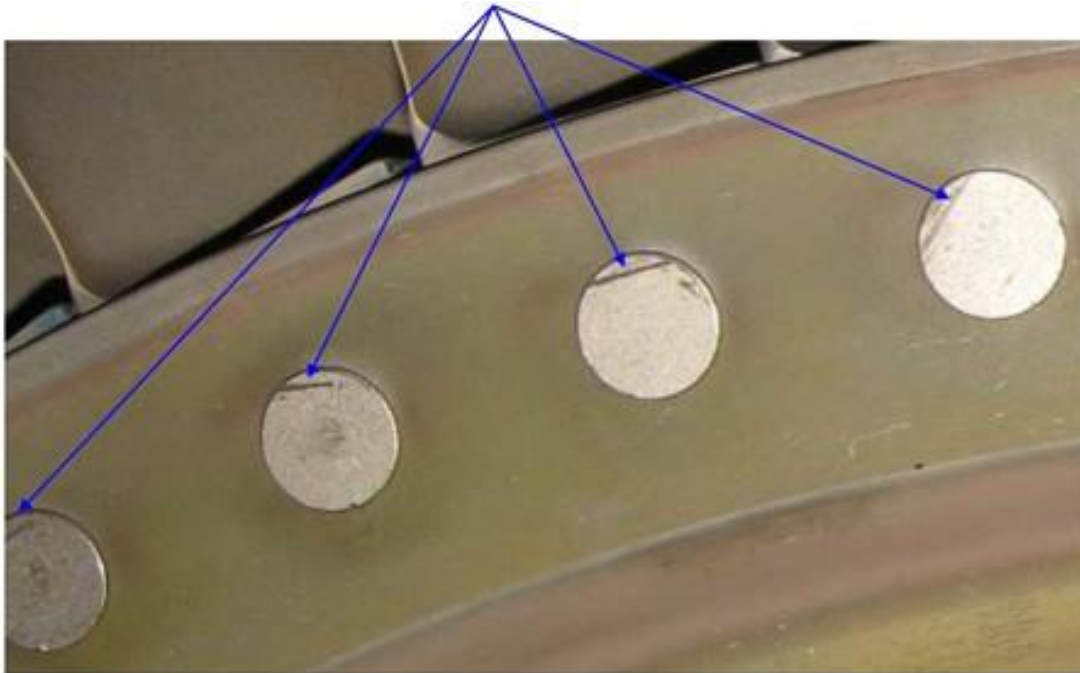
Figure 5, Witness Marks Showing Incomplete Rivet Head Support

During the rivet flaring process, the rivet head is supported by a tool that incorporates a mandrel that should support the entire rivet head while the rivet is flared (see Figure 6 & 7). As shown below in Figure 5, examination of some of the rivets still installed in the disk showed evidence of incomplete support of the rivet head during the flaring process. If the entire rivet head is not supported during the flaring process, a bending stress would be generated at the rivet radius which could contribute to head liberation.

During the rivet flaring process, when the rivet is installed into the 7th stage disk and the disk is set upon the disk support tool (PWA 33565) as shown below in Figure 6 and described in step 1 of task 72-36-02-44-003-002 (JT8D-1/17 EMM for PN 481672) or in task 72-36-02-44-003-003 (JT8D-209/219 for PN 773128). Prior to flaring the rivet, the rivet head must be fully supported by the mandrel as shown in Figures 7 & 7a.

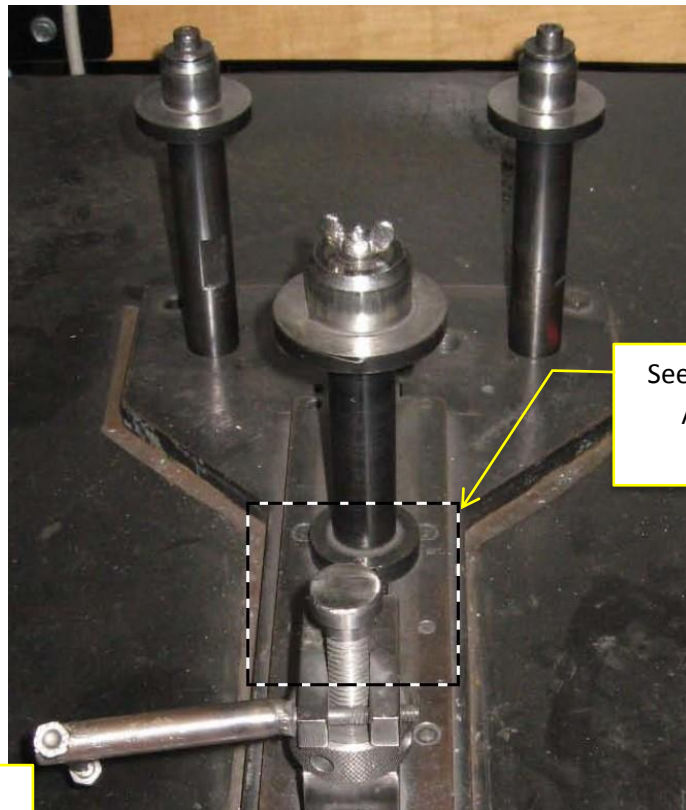
Figure 7, Disk Support Tool

Simulated Rivet Head
Correct Position, Fully
Supported By Mandrel

Simulated Rivet Head
Incorrect Position, Only Partly
Supported by Mandrel
