SERVICE INFORMATION LETTER

SIL # 171017-23072-1400WE

SUBJECT: The outer diameter of the heat shrink tubing on the Speed Pickup is too large and causes difficulty during installation into the NHA.

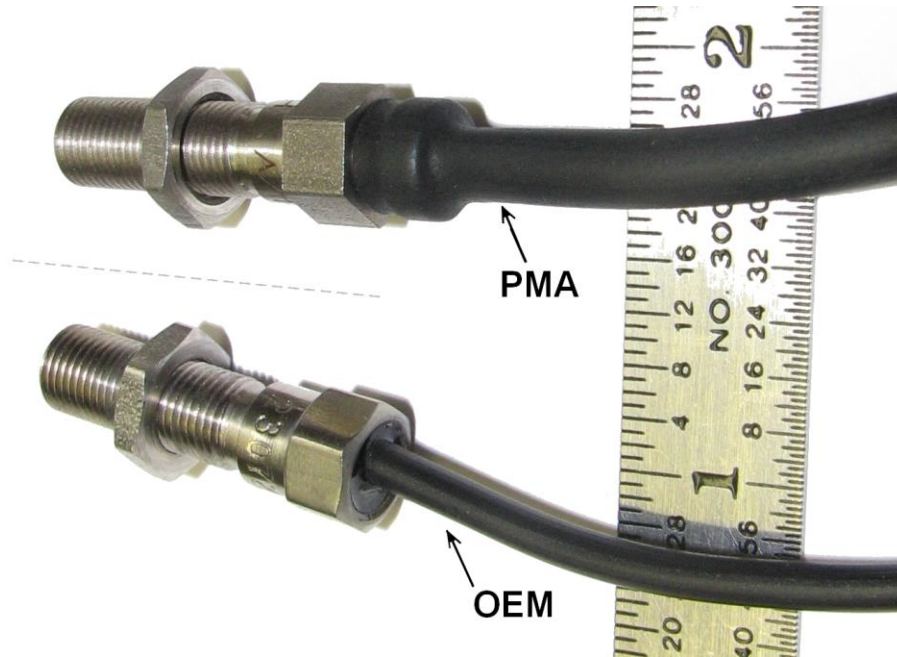
Some customers have complained that the OD size of the heat shrink tubing is causing difficulty installing the Wencor Speed Pickup. The OD size of the Wencor Speed Pickup is approximately 0.175", while the OD size of the OEM is only approximately 0.115". The Speed Pickup wires that are covered by heat shrink tubing must pass through a grommet when installed on the NHA DC Starter-Generator as shown in Figure 3. The larger size heat shrink is more difficult to pass through the grommet.

Figure 1, Side-by-Side Image of Speed Pickup Showing Heat Shrink Tubing

Any Wencor Speed Pickup Assemblies that are currently uninstalled that have been purchased prior to the date of this SIL may be returned to Wencor for replacement at the discretion of the end user.

However, any Wencor Speed Pickup Assemblies that are currently installed into the NHA, passed the required CMM testing for the NHA and are in service, may remain in service at the discretion of the end user with no risk to normal operation.

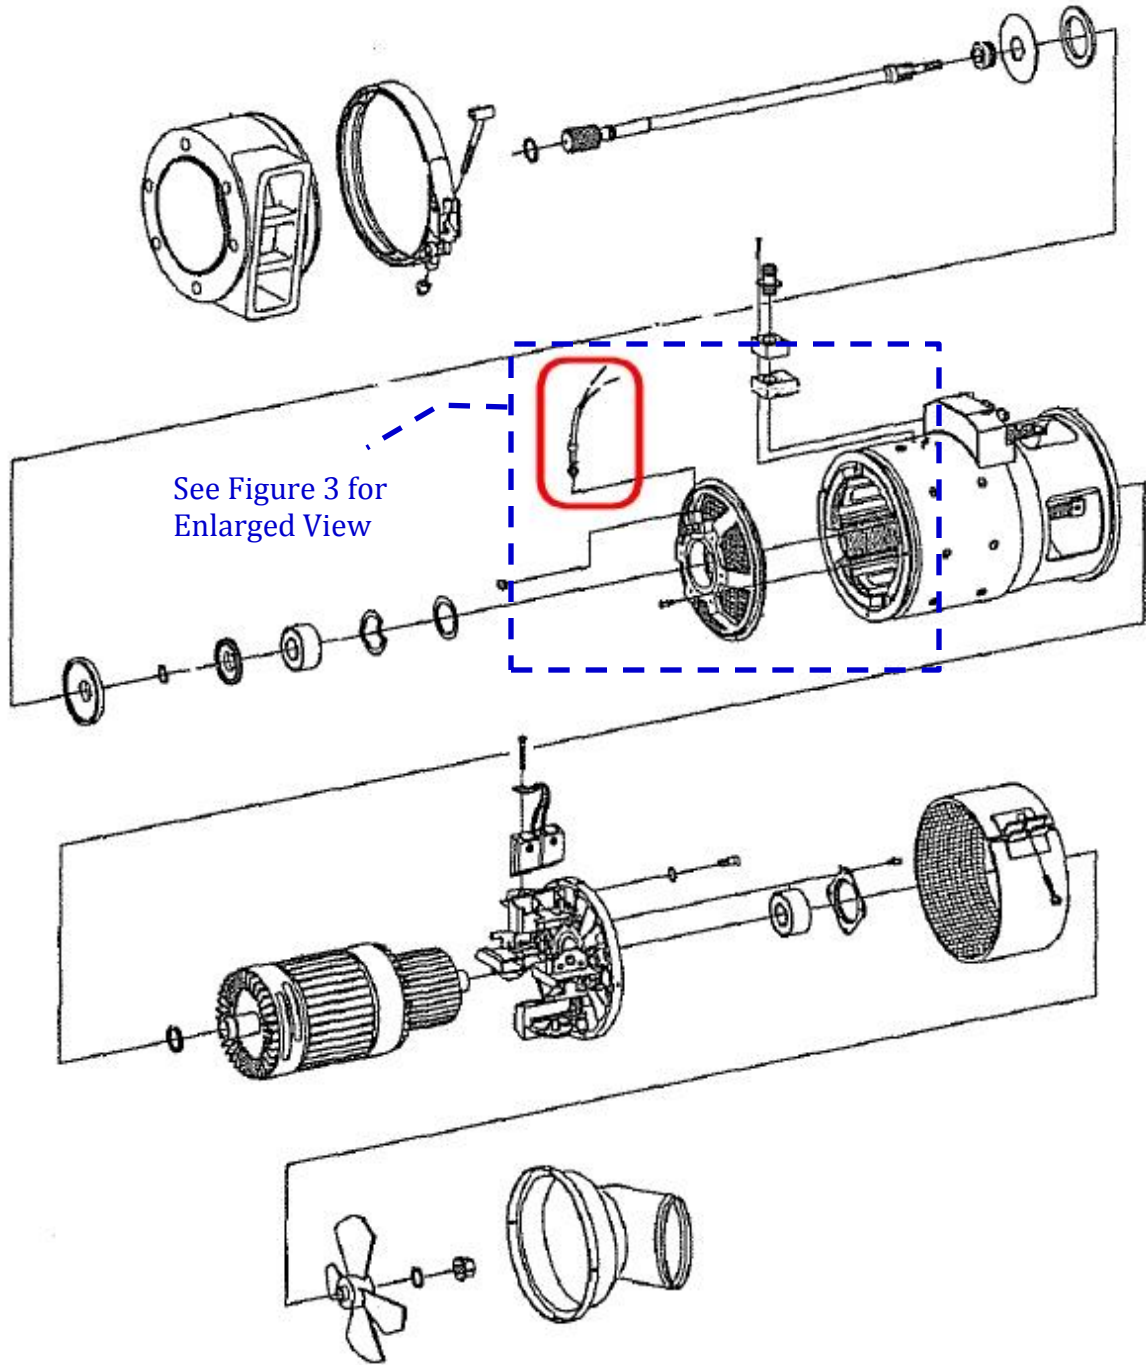
Figure 2, Exploded View of Starter-Generator Showing Speed Pickup Assy

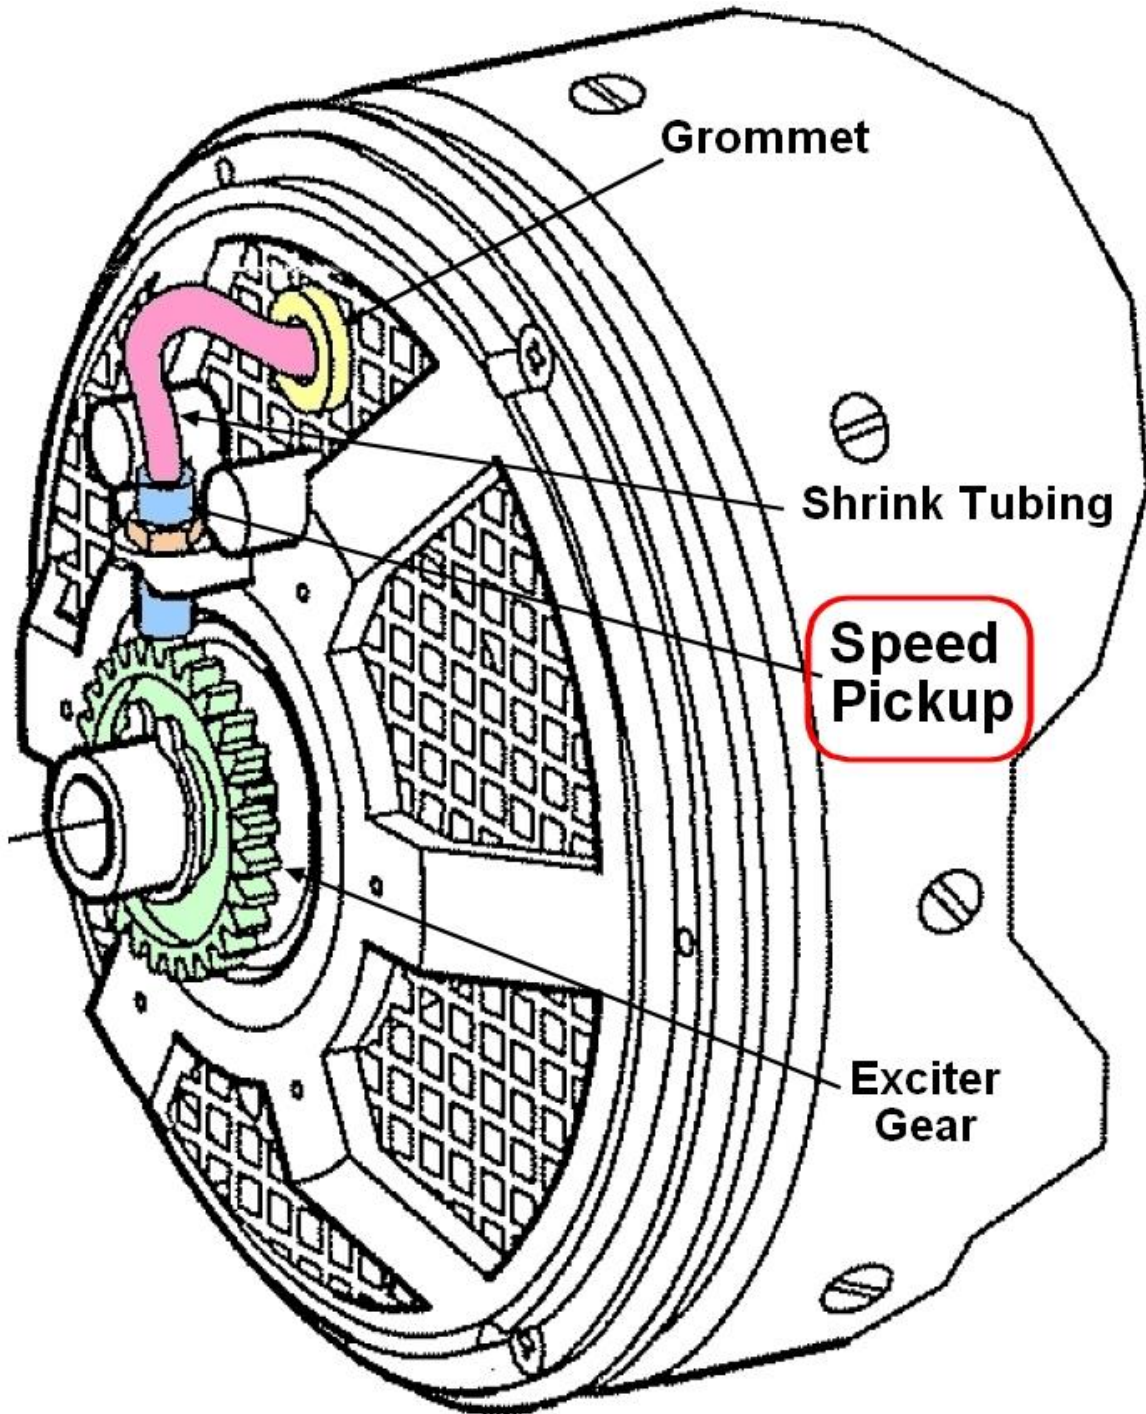
Figure 3, Installed Image of Speed Pickup Assy
