SERVICE INFORMATION LETTER

Subject: Installation Recommendations for Wencor Tubular Rivet PN 800162WE, installed in the JT8D Engine 7th Stage High Pressure Compressor (HPC) Disk.

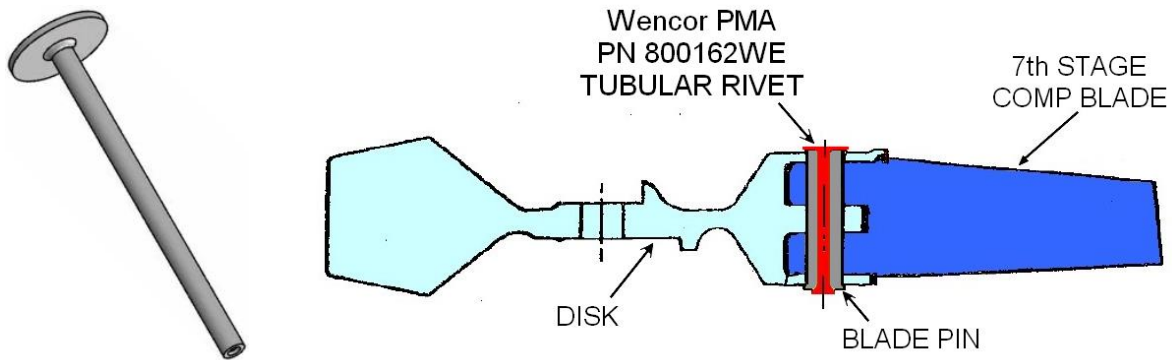
Figure 1, Rivet ISO View & Section View of Installed Rivet

During an investigation of in-service failed Wencor Tubular Rivets PN 800162WE as described in Service Bulletin 130617-001, Wencor discovered contributing factors in the rivet failure that occurred during the process of installing and flaring the rivet during the assembly of the 7th stage disk. This SIL provides some recommended installation and flaring actions (see section 4) to the assembly process that will reduce the potential of in-service rivet failure.
